STRUCTURAL ASSESSMENT LETTER REPORT

**LEBANON FIRE STATION
13 UPPER CROSS ROAD
LEBANON, MAINE**

Prepared for:
Town of Lebanon

September 6, 2023

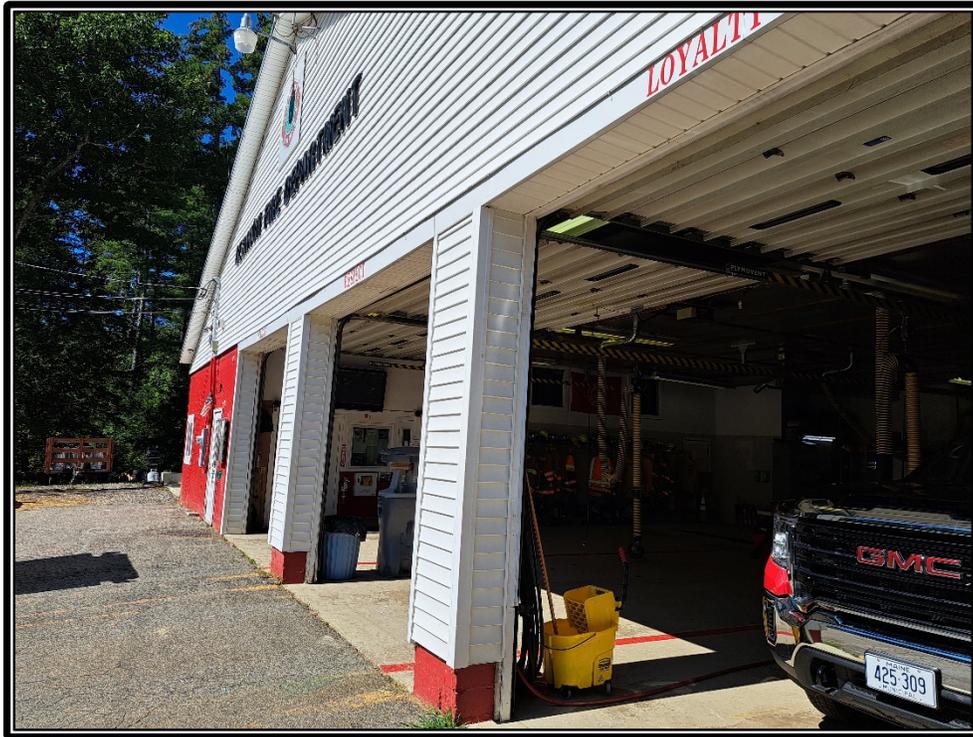
The existing single-story, concrete masonry unit (CMU), and wood-framed building is approximately 65 feet wide and 60 feet deep. There are three overhead garage doors and one standard entry door along the front (southern side) of the building (see Photo 1 in Appendix A). A frost wall and concrete slab were recently constructed for a new addition on the western side of the building, but the addition was never completed. A portable office trailer was parked on the slab and was being used as the office for Fire Chief Stefano (see Photo 2). The Town is currently considering either repairing the existing building or constructing a new fire station.

Photo 1: Front of building.

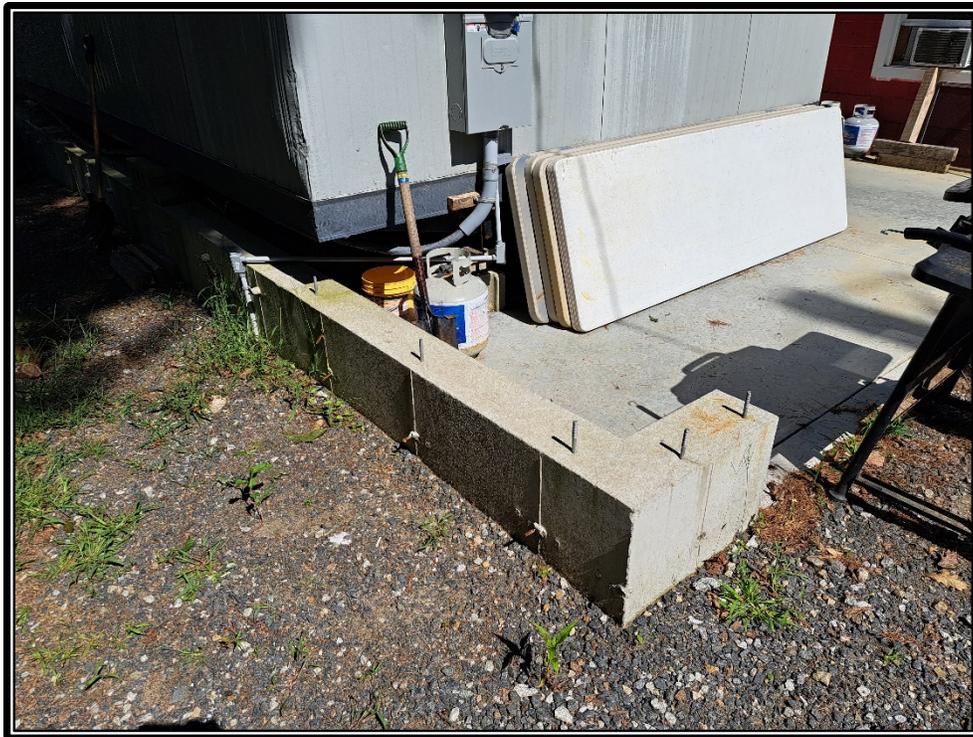
Photo 2: Frost walls and slab on western side of building.

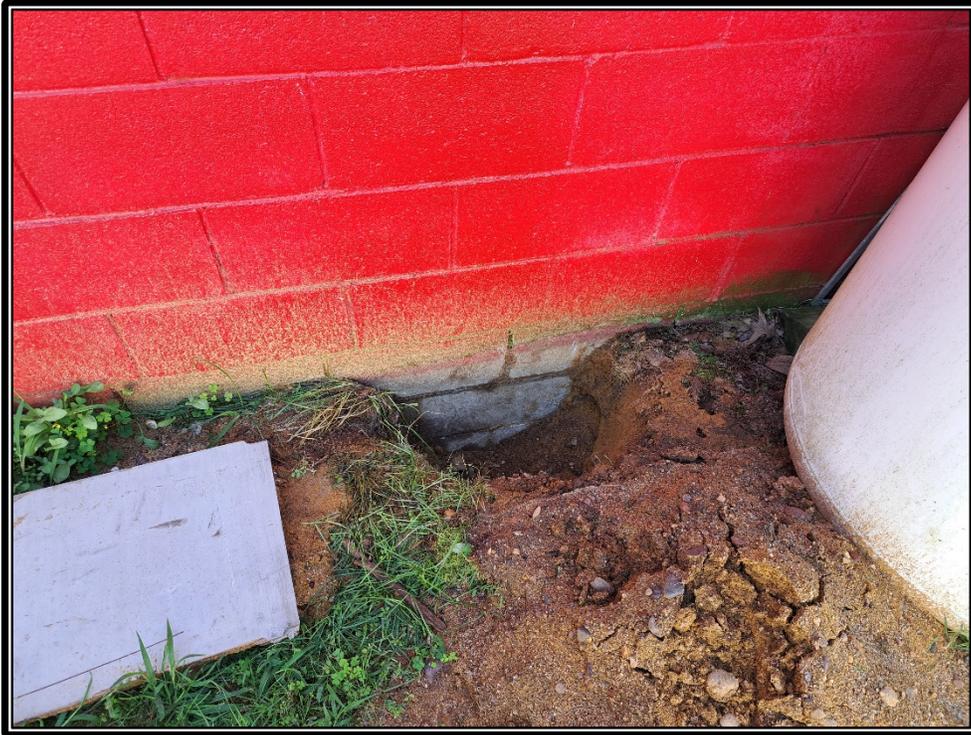
The walls of the building are constructed of CMU blocks and extend below grade to a concrete footing. A hole had been dug on the northern side of the building to expose the top of the footing. The footing was observed to be 16 inches below the ground surface (see Photo 3). The footing is exposed, at ground level, at the northeast corner of the building (see Photo 4). Typically, footings are buried 4 feet to protect them from the frost. The exact size of footings and presence of reinforcement is unknown.

Photo 3: Hole dug on northern wall to expose footing.

- » Perform a geotechnical assessment of the site, with borings, to determine the soil bearing capacity and frost susceptibility. Review the adequacy of the existing footings.

- » Remove all of the finishes from the inside of the building in order to view all of the existing structures.
- » Add a horizontal layer of rigid insulation over the existing footings to protect them from frost.

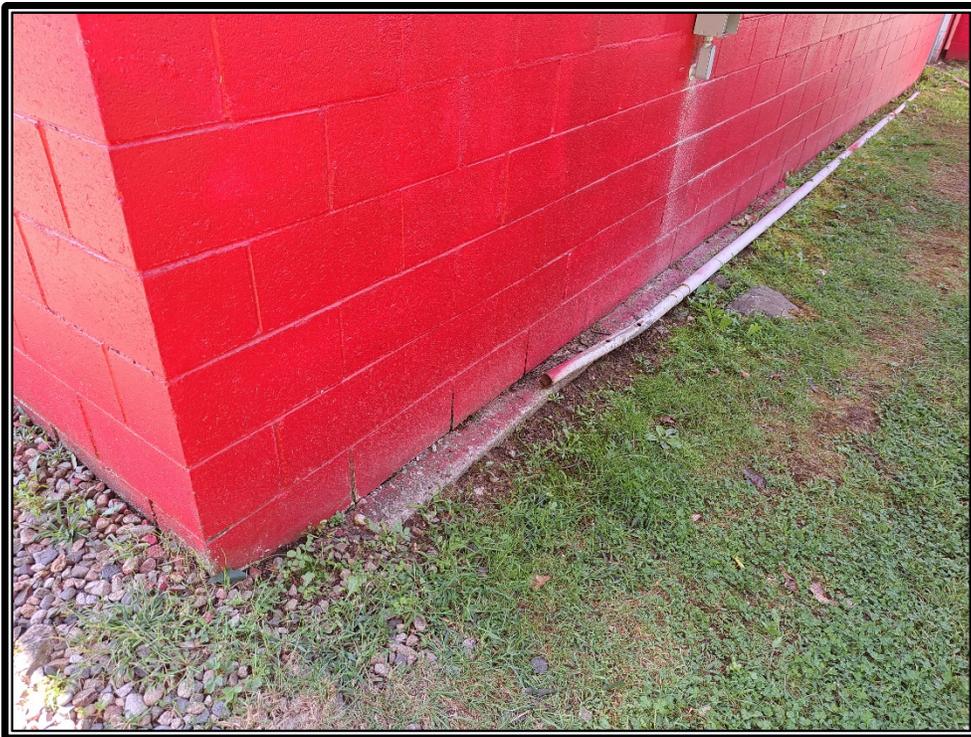
Photo 4: Exposed footing on northeast corner of building.

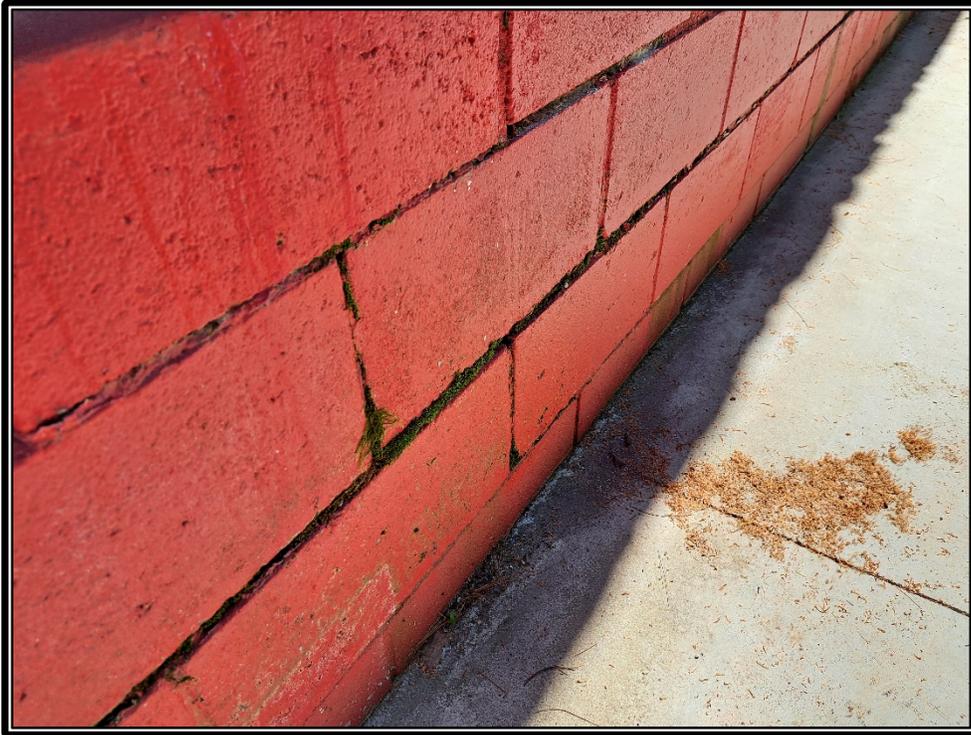
The CMU block walls are in fair to poor condition. Based on my observations, it is assumed that the CMU blocks are unreinforced and the cells are not fully grouted. The grout between the blocks is soft and missing in many areas. Moss was observed to be growing between the blocks in several locations near the bottom of the wall (see Photo 5). Portions of the western and southern walls are leaning out approximately ½-inch over 4 feet. There are several cracks in the mortar between the blocks of the western wall some of which have been patched with spray foam and caulking (see Photo 6). Some of the blocks at the top of the western wall have cracked and pushed out from the rest of the wall (see Photo 7). Exterior frames and flashing are missing from two of the windows on the western wall (see Photo 8). The CMU chimney on the northern side of the building is leaning and does not appear to be properly attached to the adjacent wall (see Photo 9).

Photo 5: Moss growing mortar between blocks.

- » Remove mortar and re-point all of the exterior CMU walls.
- » Remove and replace the existing chimney.
- » Remove and replace the existing settled slabs and under-slab piping.

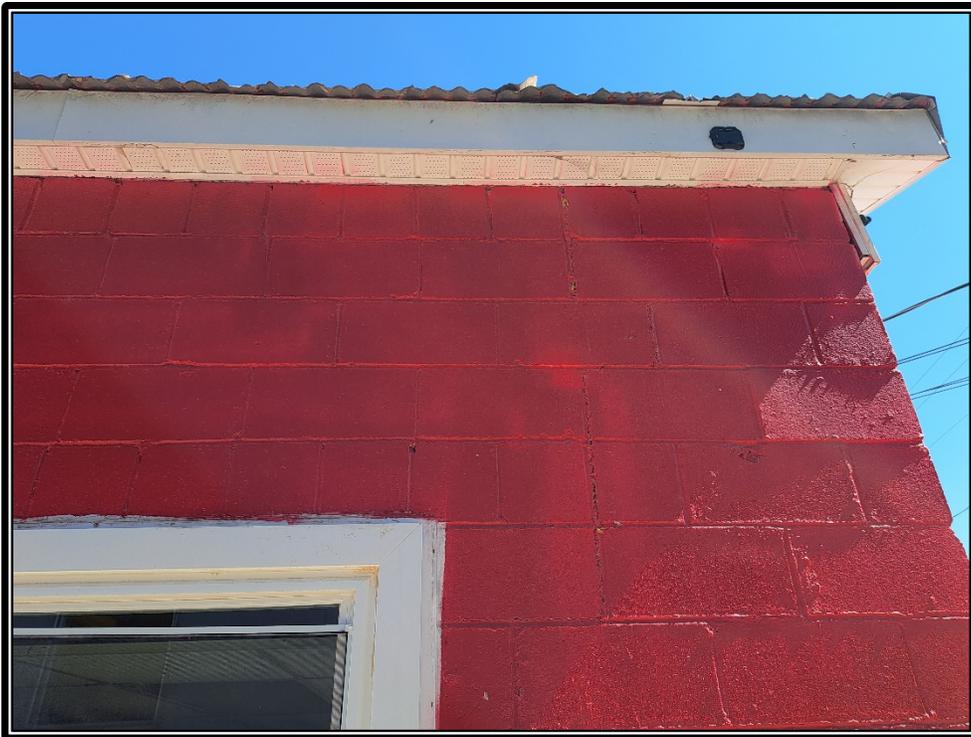
Photo 6: Cracks between blocks filled with caulking and spray foam.

- » Reinforce the existing CMU walls by cutting into the blocks as necessary, installing reinforcing bars, and fully grouting the cells.
- » If necessary, install proper lintels in the CMU walls, and over the doors and windows.

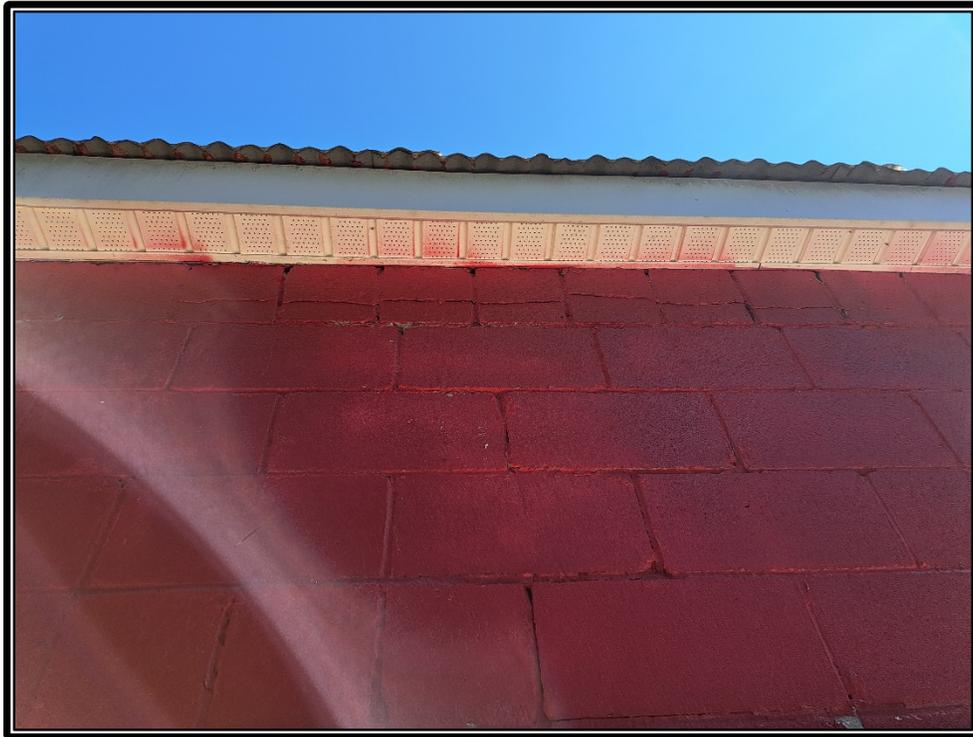
Photo 7: Cracked and displace blocks along top of western wall.

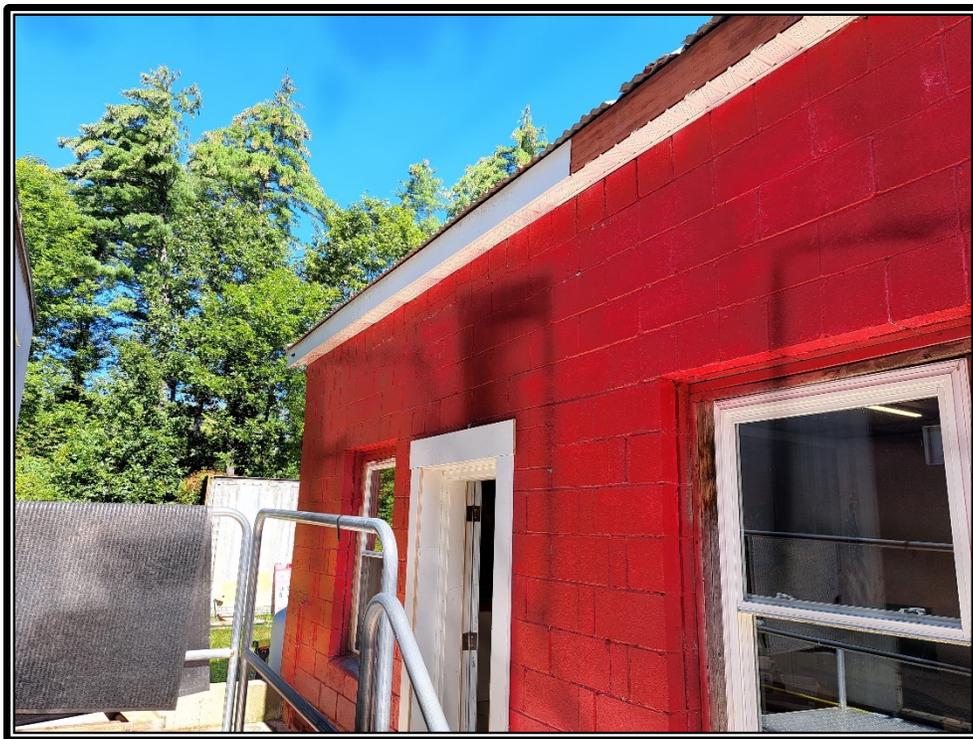
Photo 8: Missing window frames.

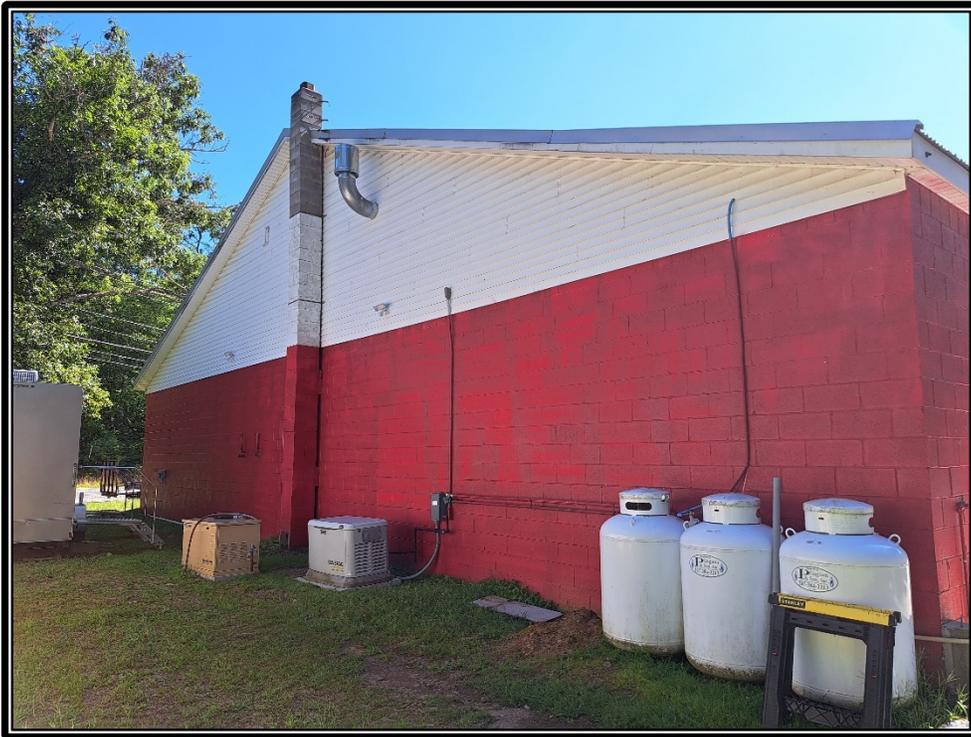
Photo 9: CMU chimney on northern wall.

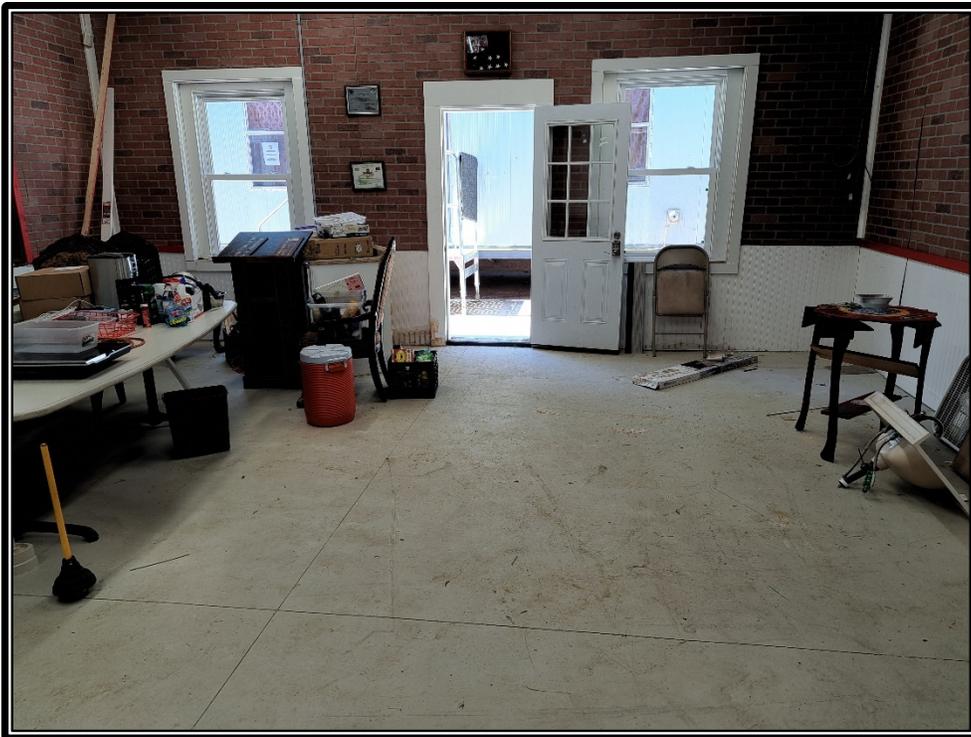
Photo 10: Newly repaired slab.

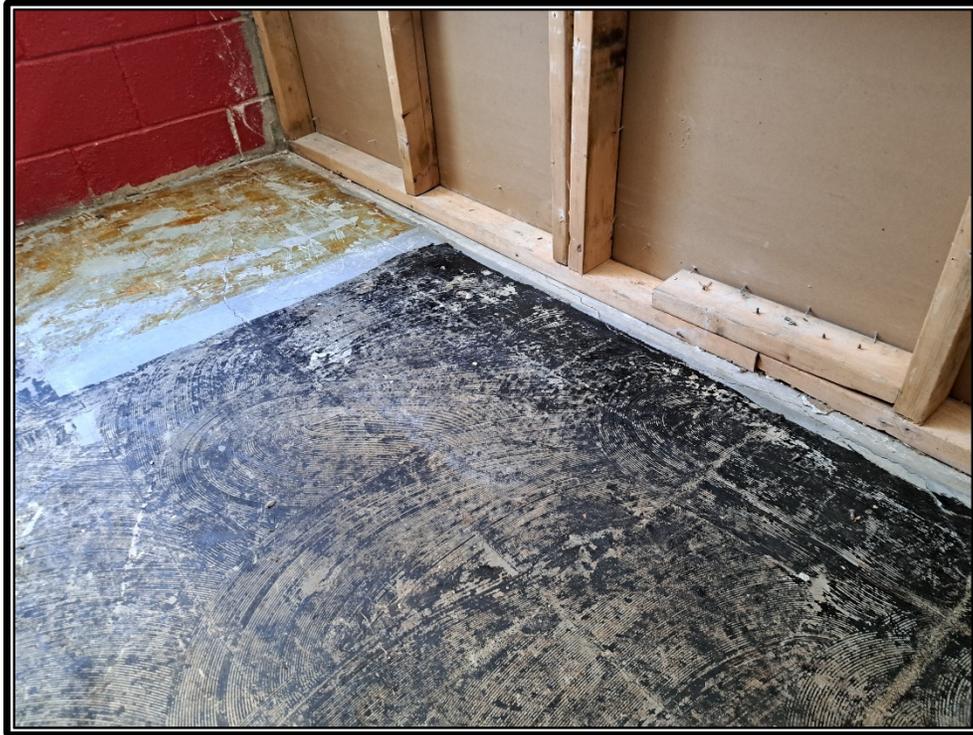
Photo 11: Cracked and settling slab in kitchen.

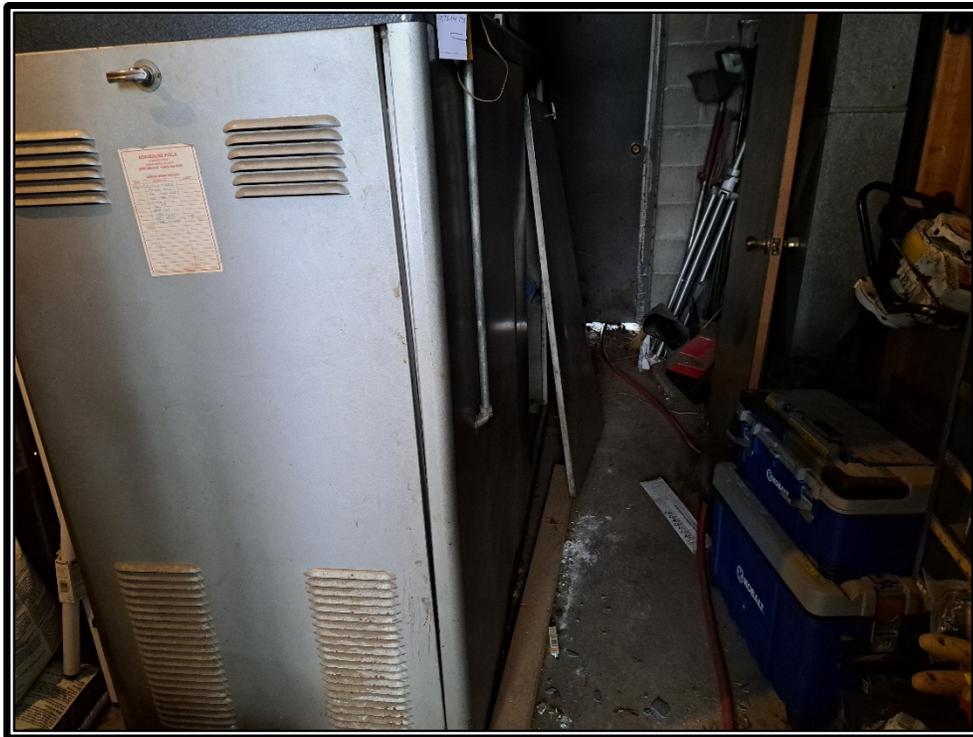
The floor of the building has a concrete slab-on-grade with a trench drain in the rear portion of the garage bays. The floor slab in the southern portion of the building is in good condition with only minor cracks. You told me that the hole in the floor slab, that was observed in the northwest room during my previous visit, was filled with concrete. You also said that since the repairs, this room has flooded several times due to water leaking through the doorway and exterior western wall (see Photo 10). You told me that there was an issue with the sewer pipes that run under this slab backing up. The sewer pipes were scoped and found to be settling and separating in several locations. The floor slab in the kitchen area is cracked and has settled approximately ½-inch over 2 feet (see Photo 11). The floor slab in the boiler room near the back of the building is cracked and has settled approximately 4 inches over 4 feet near the back door (see Photo 12).

Photo 12: Cracked and settling slab in boiler room.
